# Special Report 85-2

## *Survey of ice problem areas in navigable waterways*

Jon Zufelt and Darryl Calkins

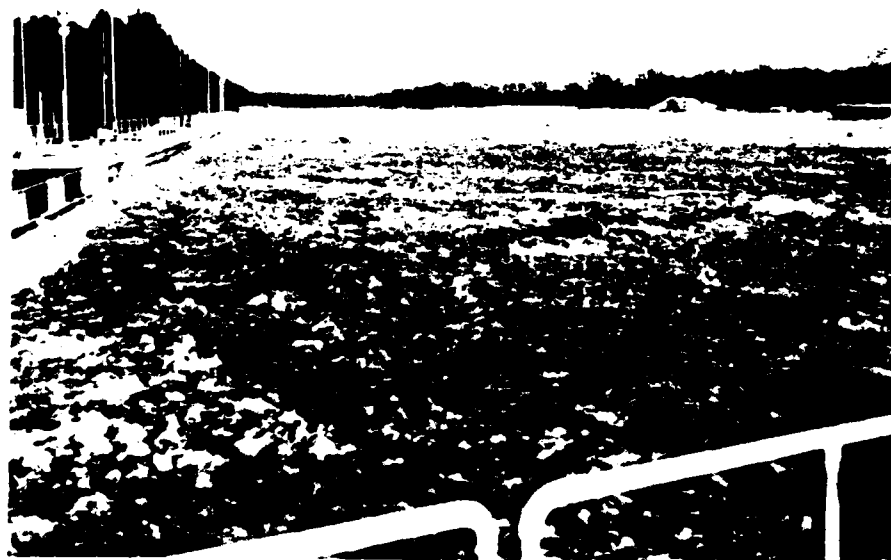
Broken ice carried downstream by the river current or wind often accumulates in the upper lock approach, causing delays (Fig. 1). Separate ice lockages often must precede the locking of downbound tows, and flushing ice during these ice lockages is difficult. Occasionally a tow must back out of the lock after entry, because the ice doesn't compact in the chamber as much as expected, preventing the tow from fully entering the lock chamber and thus causing further delays. Upbound tows may have to limit their size to be assured of enough power to push through the accumulations of ice. During periods of low traffic, these accumulations sometimes freeze in place, causing further delays and difficulty in operating the upper gates. Air bubbler curtains have been used at some installations to deflect ice from the lock ap-

Figure 1. Ice in upper lock approach.

proach. Towboats sometimes align their barges to act as a deflector wall while awaiting downbound lockage. Some locks are equipped with emergency bulkheads that are placed in the small lock chamber to act as spillways, flushing ice from the upper approach. One respondent cited that with greater towboat approach velocities, the ice is pushed to the sides of the incoming barges, rather than being directed forward into the lock chamber.

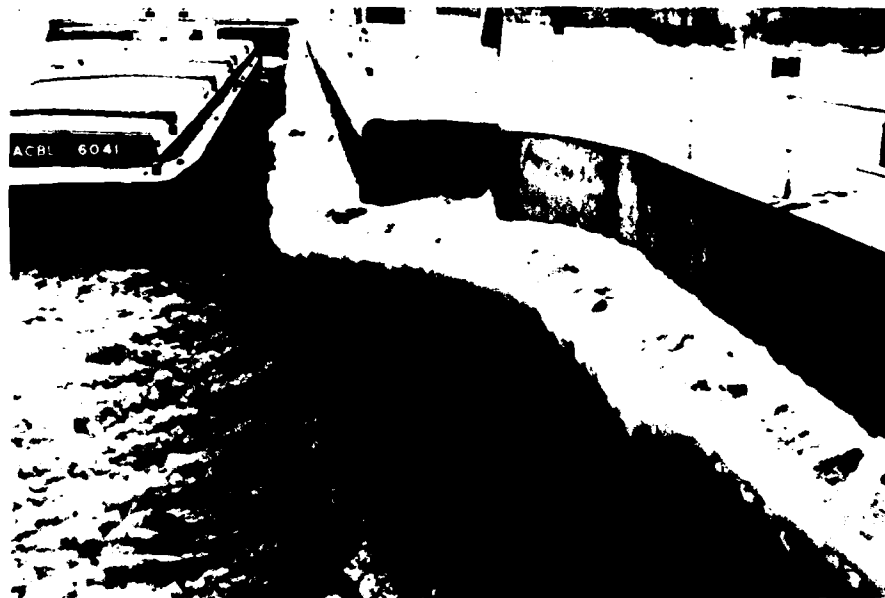
Figure 3. Ice buildup on lock walls and miter gate recesses.

During extremely cold weather, and with fluctuating water levels in lock chambers, ice will build up on the lock walls and miter gates, forming a collar (Fig. 3). This collar is thickest at the upper pool level. Sufficient buildup can occur on the walls to restrict the gates from being fully opened, thus limiting the width of tows and presenting the potential for gate damage. Even where the buildup is minimized or controlled in the gate recesses, ice on the chamber walls can be thick enough to restrict tow widths. The most common methods for removing ice buildups on lock walls and miter gates are chipping and steaming. Less labor-intensive means include electric heaters on gates and wall recesses and the application of copolymer ice coatings. Ice coatings are reported to work well on lock walls but have had limited success when applied to the miter gates.

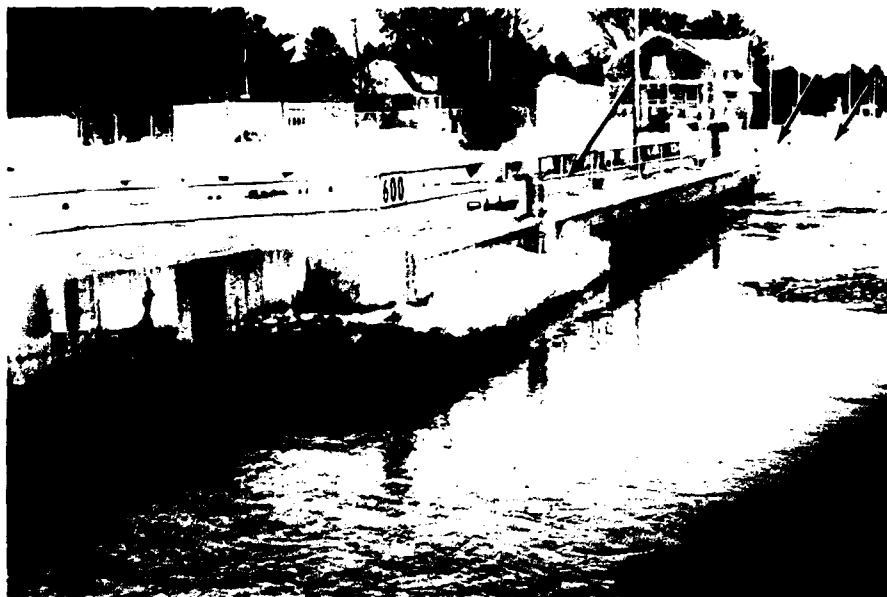
Ice pieces may jam between the floating mooring bitts and the lock wall, rendering the bitts inoperative. Ice layers may build up on the wheels or track of a bitt (Fig. 4), causing it to freeze in place and/or jump upward unexpectedly from a submerged position. Usually, bitts are tied off at the top of the lock wall and remain unavailable for winter use. Oil-fired hot water heaters have been used to keep floating mooring bitts free of ice accumulations. One facility has achieved good results from applying copolymer ice coating to the tracks and wheels of their bitts.

Figure 4. Floating mooring bitts jammed by ice accumulations.

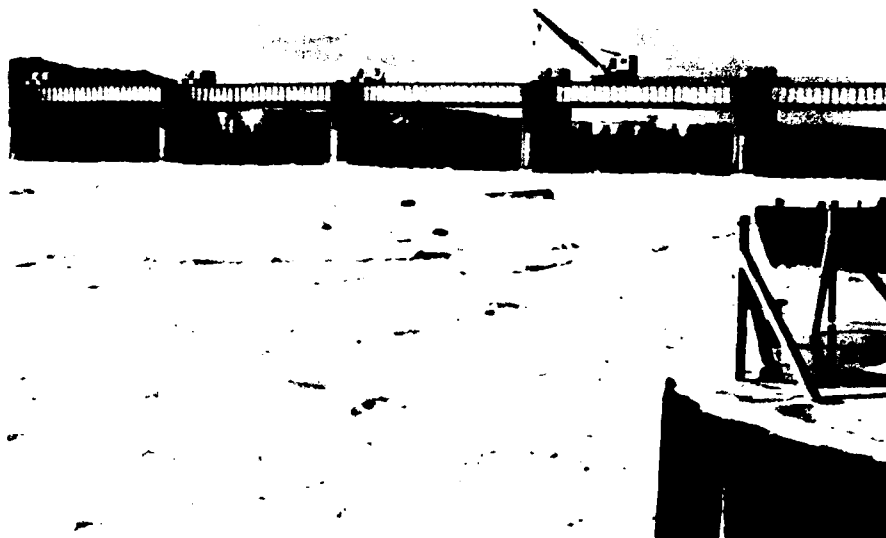
Broken ice carried downstream usually accumulates at the navigation dam (Fig. 5). During periods of low flow, normal gate openings are small and will not pass this ice. Low tailwater presents a problem of excessive scour if gates are raised high enough to pass the ice. In colder weather these accumulations will freeze in place, making it necessary to break up the ice in order to start it or keep it moving. Towboats provide assistance to the lock and dam facilities in this respect. Some lock and dam facilities have been equipped with submergible tainter gates, specifically designed for passing ice and drift. At a few installations, the gates are rarely used in the sub-

Figure 5. Ice buildup behind dam spillway gates.

merged settings due to excessive vibrations, which could cause damage to the gate and supporting structure of the dam. Some of these submergible gates have been retrofitted to prevent them from being used in the submerged position. Other lock and dam facilities report no problems with operating their gates in the submerged position. Three installations on the Monongahela River are equipped with split-leaf tainter (movable crest) gates designed for passing ice and debris. The gates are reported to work well, but during periods of low flow, towboat assistance is required to break up the ice behind the dam and start it moving. One facility reported that an emergency bulkhead placed over a roller gate bay passes ice well. Another lockmaster rotates the openings of the dam gates to keep the ice moving.

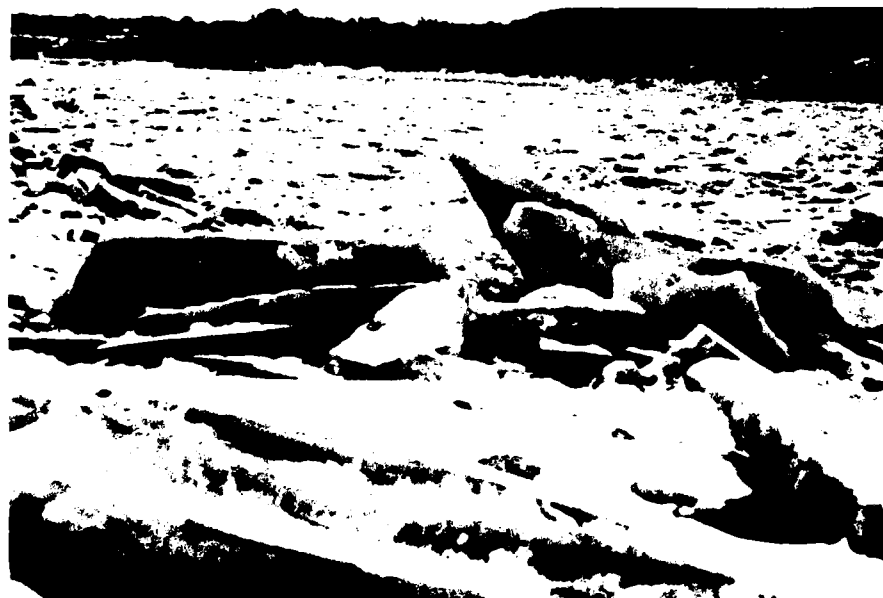
The channels around islands, bends, and other constrictions tend to accumulate thick deposits of ice (Fig. 8). During significant ice periods these accumulations may form jams, which can cause scouring and eroding of bed and banks. Navigation can be interrupted or delayed and structural damage is possible, especially during breakup of the jam. Minor jams may raise the water level upstream, while major jams can cause severe flooding. Tows must limit their size in some problem areas.

Figure 8. Section of Ohio River showing severe accumulation of ice in navigation channel.
